Meridian Streetscape Project

Project Description

The following graphics depict the proposed streetscape improvements for the City of Meridian downtown core.

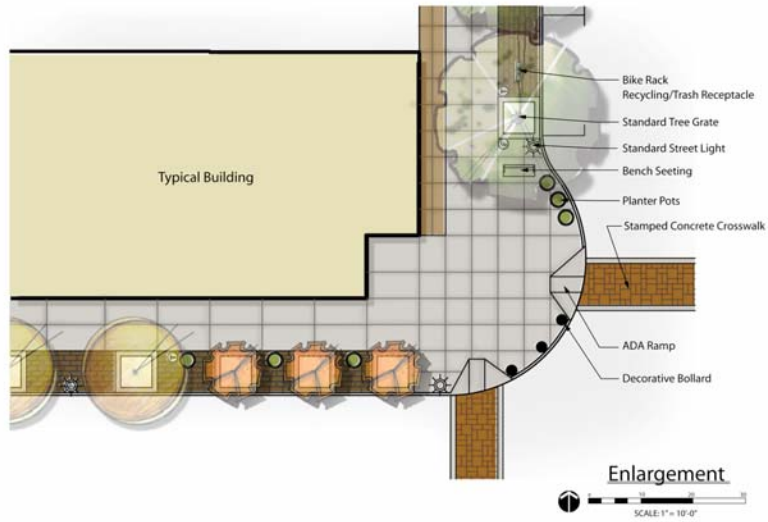
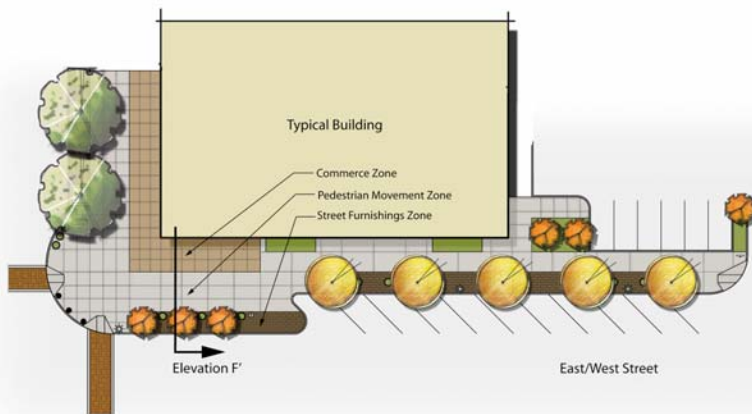
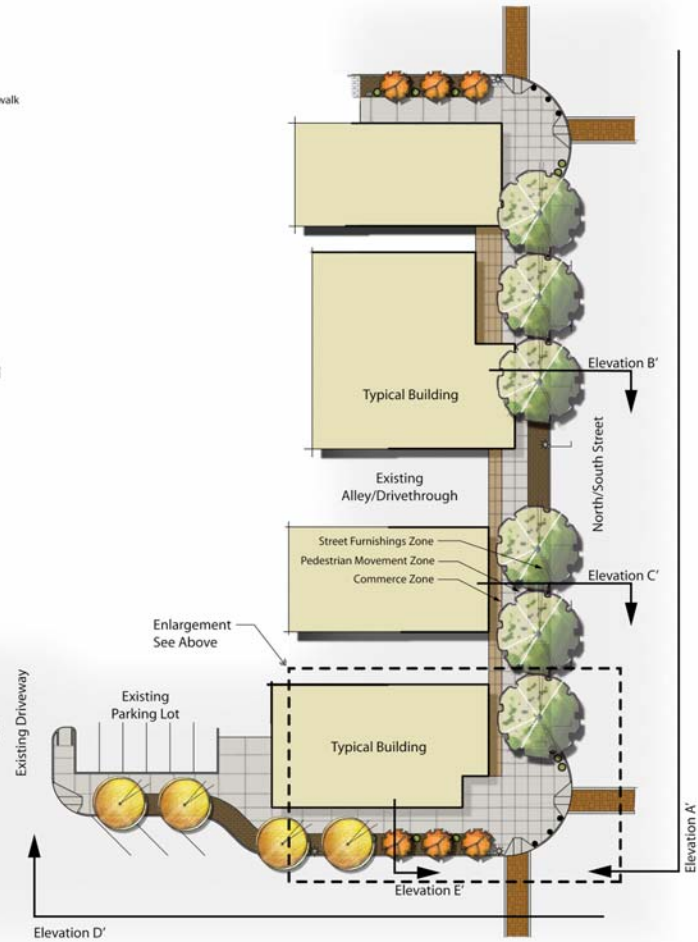
Proposed Site Plan

SCALE: 1" = 20'-0"

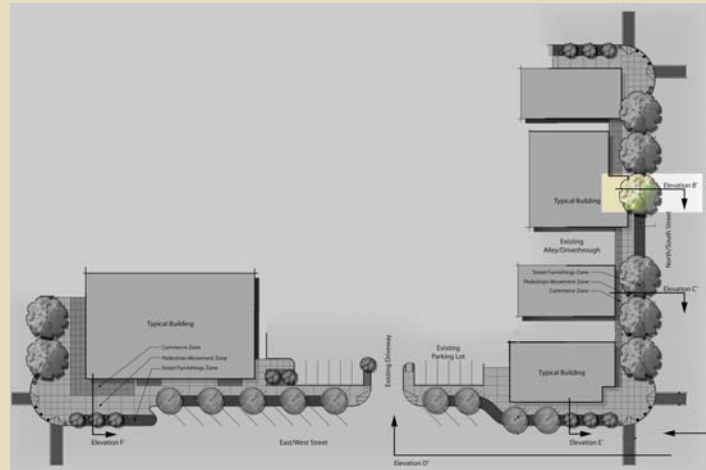
Elevation 'B'

Scale: 1"=10'-0"

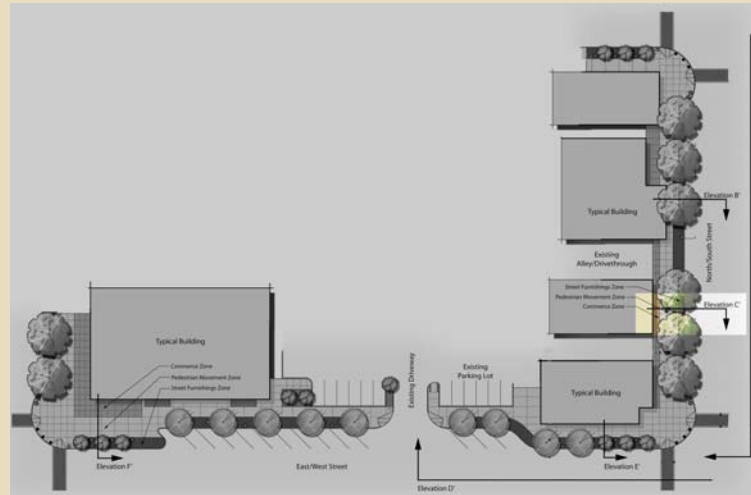
Elevation 'C'

Scale: 1"=10'-0"

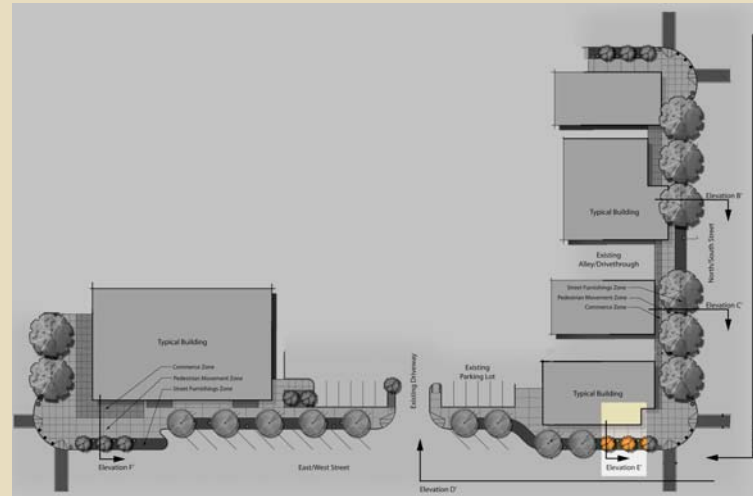
Elevation 'E'

Scale: 1"=10'-0"

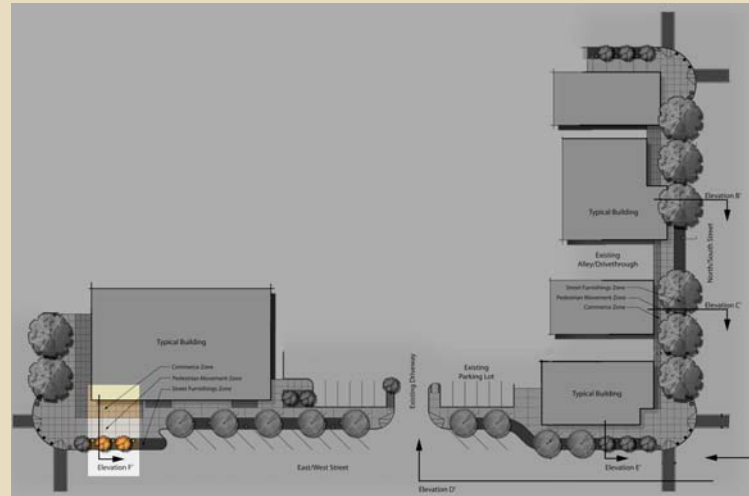
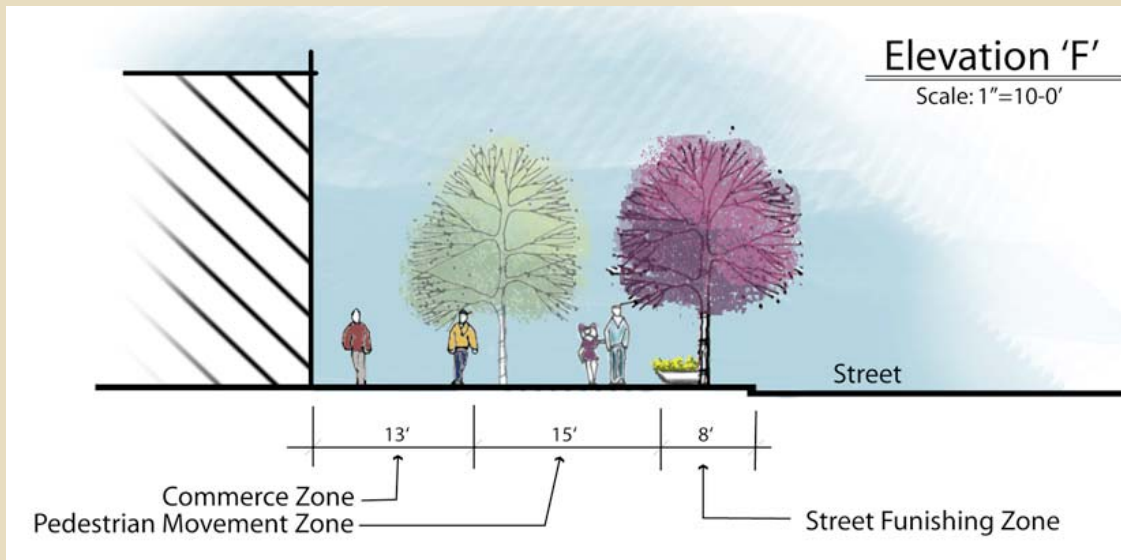
Elevation 'F'

Pedestrian Movement Zone
Street Furnishing Zone

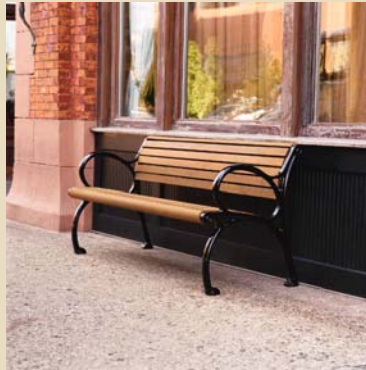
Bench 1

Material: Black Aluminum frame with wood slats

Initial cost: Medium

Maintenance cost: High

Material: Black Aluminum frame with wood slats
Initial cost: Medium
Maintenance cost: High

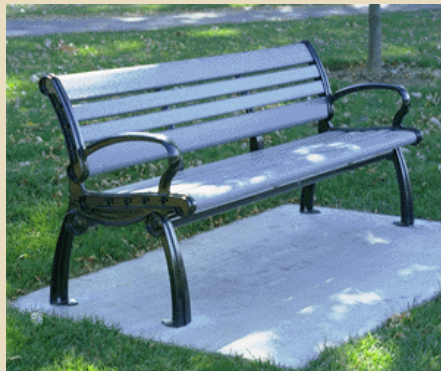
Bench 2

Material: Black aluminum frame with Durawood recycled slats

Initial cost: Medium

Maintenance cost: Low

Material: Black aluminum frame with Durawood recycled slats
Initial cost: Calling
Maintenance cost: Low

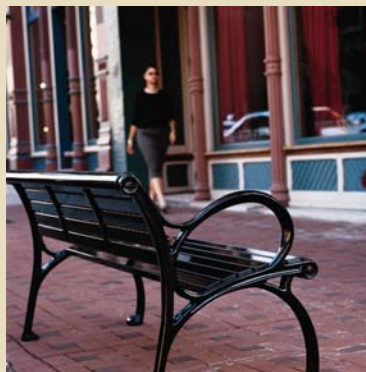
Bench 3

Material: Black Aluminum

Initial cost: High

Maintenance cost: Low

Material: Black Aluminum
Initial cost: High
Maintenance cost: Low

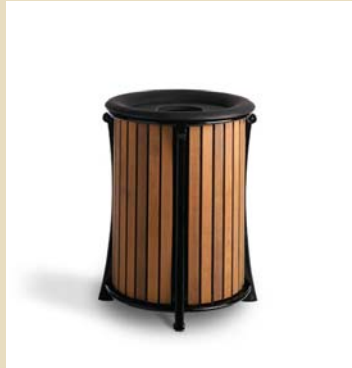
Trash Receptacle 1

Material: Black Aluminum frame with wood slats

Initial cost: Medium

Maintenance cost: High

Material: Black Aluminum frame with wood slats
Initial cost: Medium
Maintenance cost: High

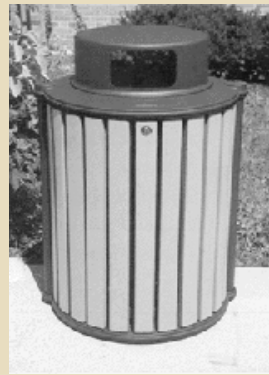
Trash Receptacle 2

Material: Black aluminum frame with Durawood recycled slats

Initial cost: Medium

Maintenance cost: Low

Material: Black aluminum frame with Durawood recycled slats
Initial cost: Calling
Maintenance cost: Low

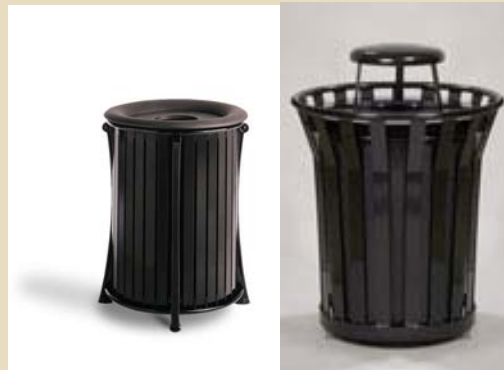
Trash Receptacle 3 & 4

Material: Black Aluminum

Initial cost: High

Maintenance cost: Low

Material: Black Aluminum
Initial cost: High
Maintenance cost: Low

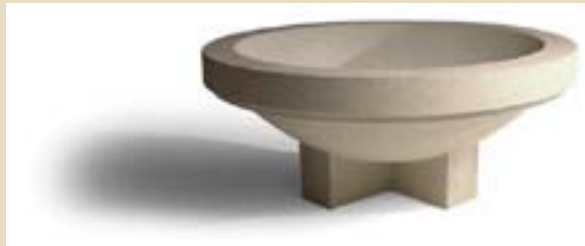
Planter 1

Material: Concrete
Color: Grey
Initial cost: Medium
Maintenance cost: Low
Feature: Drip Irrigation Provided

Material: Concrete
Color: grey
Initial cost: Calling
Maintenance cost: Low
Feature: Drip Irrigation Included

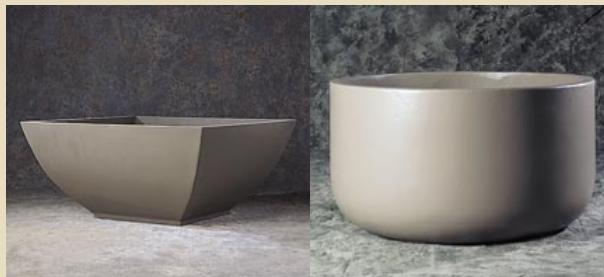
Planter 3 & 4

Material: Concrete
Color: Grey
Initial cost: Low
Maintenance cost: Low
Feature: Drip Irrigation Provided

Material: Concrete
Color: Grey
Initial cost: Calling
Maintenance cost: Low
Feature: Drip Irrigation Included

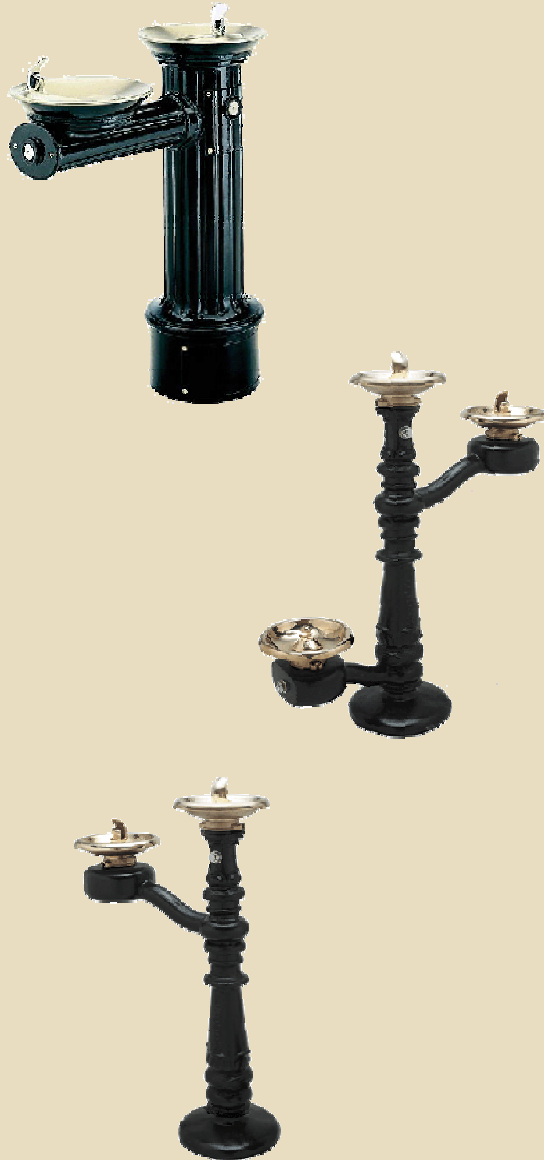
Fountain 1

Material: Black cast iron
Initial cost: Medium
Maintenance cost: Low

Fountain 2

Material: Black cast iron
Initial cost: Medium
Maintenance cost: Low
Feature: Dog Fountain

Fountain 3

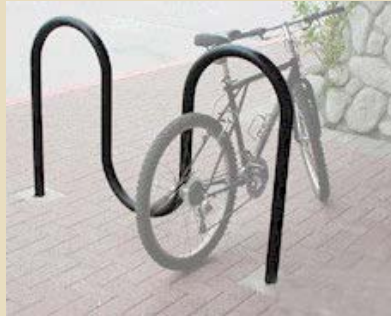
Bike Rack 1

Material: Black powdercoat steel

Initial cost: Low

Maintenance cost: Low

Material: Black powdercoat steel
Initial cost: Low
Maintenance cost: Low

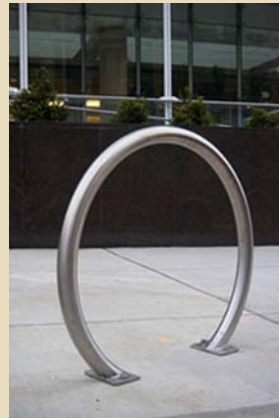
Bike Rack 2

Material: Stainless Steel

Initial cost: Low

Maintenance cost: Low

Material: Stainless Steel
Initial cost: Low
Maintenance cost: Low

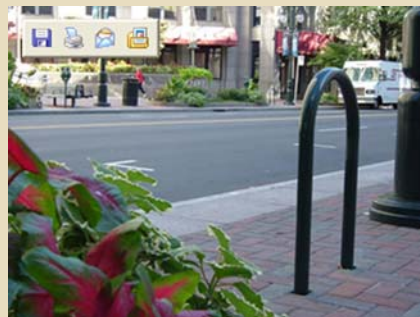
Bike Rack 3

Material: Black powdercoat steel

Initial cost: Low

Maintenance cost: Low

Material: Black powdercoat steel
Initial cost: Low
Maintenance cost: Low
